14-Foot Fall with a 15-Foot Rope

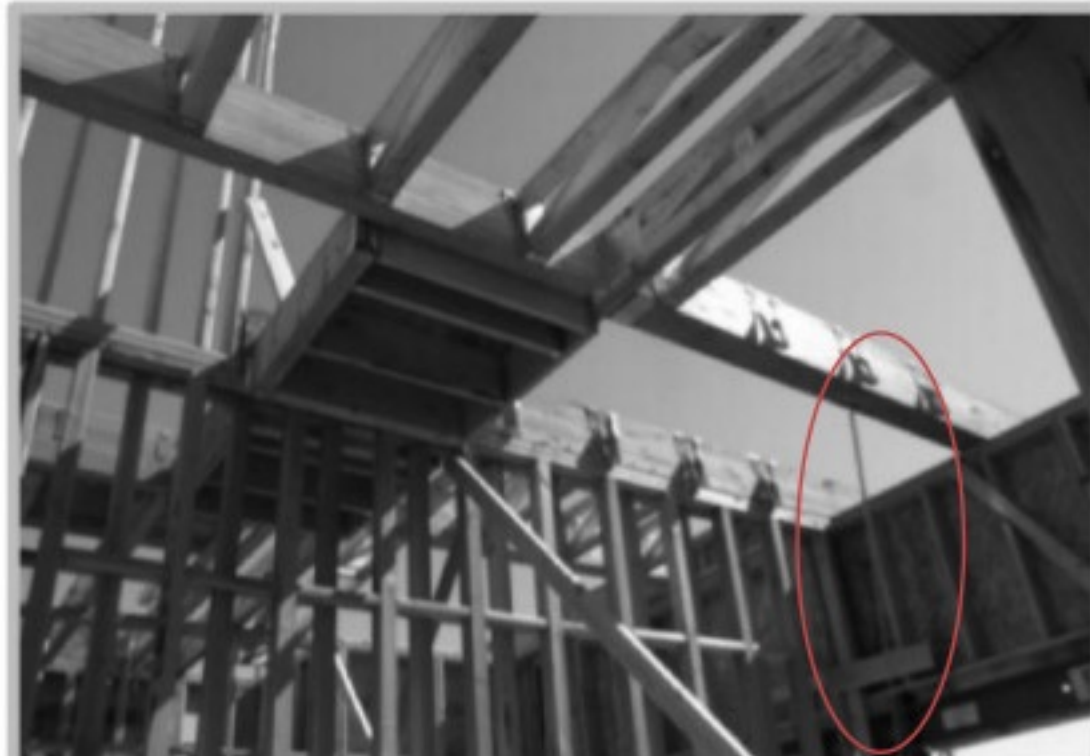
Photo of incident scene showing the opening the worker fell through while installing floor trusses.

They found the injured worker lying on the concrete of the home's garage floor, breathing but barely conscious. What else did they find? He was still connected to the rope and harness of his fall arrest system - which was anchored to a beam.

The sad irony of this incident - although the worker was wearing fall protection, the rope was too long, and it couldn't stop his fall. The foreman had warned him about the length of the rope a week before the incident.

What could have prevented this incident? Aside from the obvious - using a shorter rope - here are a few more recommendations:

1. Use an aerial work platform or scaffold where possible - if a work platform had been used in this incident, the worker could have been standing on the platform and not the beam edge.
2. Reduce exposure to falls by placing and securing plywood over the already installed trusses to create a walking/working surface to which an anchor can be secured for a personal fall restraint system.
3. Put in place a disciplinary plan and enforce it. Using the wrong PPE or using the right PPE in the wrong way should be part of the disciplinary plan. It may not always work, but in many cases it could be enough of a deterrent for employees to stop and think before making the same mistake twice.
